Sedan Range

15-13

TECHNICAL BULLETIN

Oil Pressure Gauge – Fluctuation or Low Pressure Readings – Modification Procedure

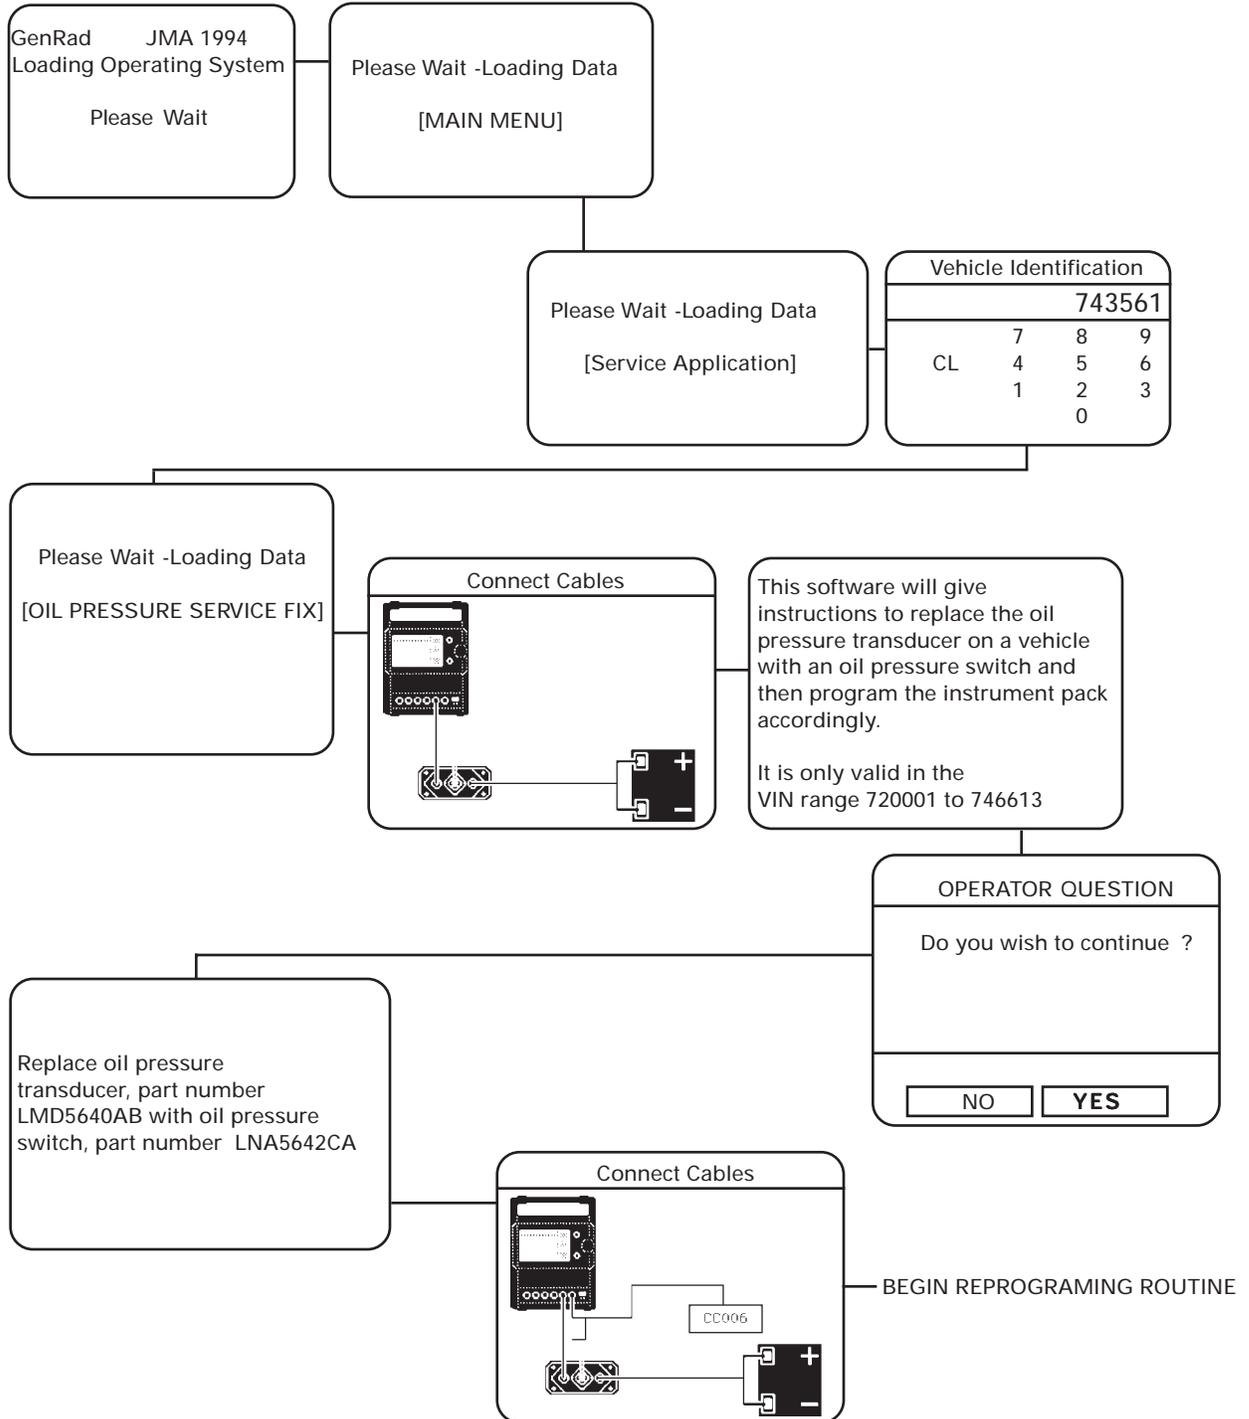
SERVICE ACTION DISC VERSION 1.0 SETUP ROUTINE:

Service Action Disc Version 1.0 is designed to reprogram the instrument pack oil pressure gauge after the oil pressure sensor is replaced by a new oil pressure switch.
