CATCHER OF THE DAY

UK mechanics have had a busy time fitting new coil-springs to cars during the first half of 2009. Andrew D. Graham, Managing Director of SUPLEX, discusses the reasons for this and offers advice to mechanics servicing Citroen C2 and C3 models which can help prevent an expensive failure on the road.

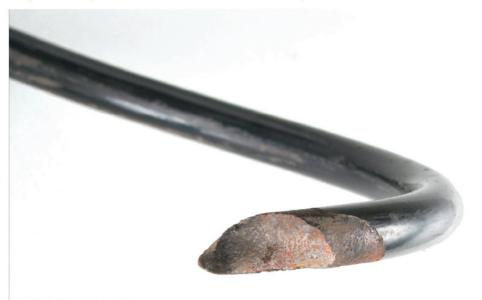
Typical, stress-corrosion fracture of a road spring

Original springs can break because an accumulation of road debris in the lower spring pan, once mixed with moisture and, in winter, road salt, will cause rapid deterioration of the spring surface coating and the spring will rust. When the spring breaks, it will almost invariably do so one half-coil in from its lower end and there is a real danger the tyre sidewall may be pierced by a sharp fragment of broken spring.

The vehicle tyre can suffer severe damage should a coil-spring fail at its lower end and fragments of broken spring make forcible contact with the tyre sidewall. The coil-spring will almost always fail in torsion and the resulting 45° fracture plane ends in a sharp point which is perfect for ripping into the relatively soft tyre sidewall. This is a real danger and the reason so many C2 and C3 models were recalled for modification.
